Hill-Rom P330 Wound Surface
 IMAP™ interface pressure mapping

**CASE STUDY
 &
 INTERFACE PRESSURE MAPPING**

Hill-Rom P330 Wound Surface
 Self-adjusting mattress replacement using
 alternating low pressure technology

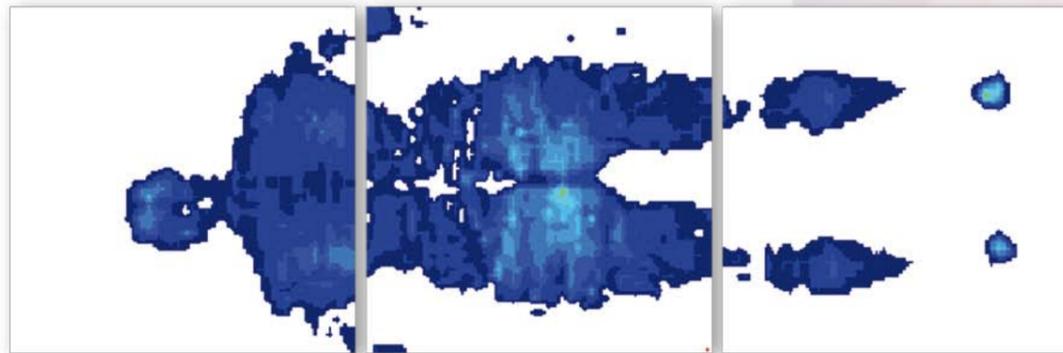
Interface pressure mapping on a 1,68 m 70 Kg woman

Supine position 0° Head of bed elevation

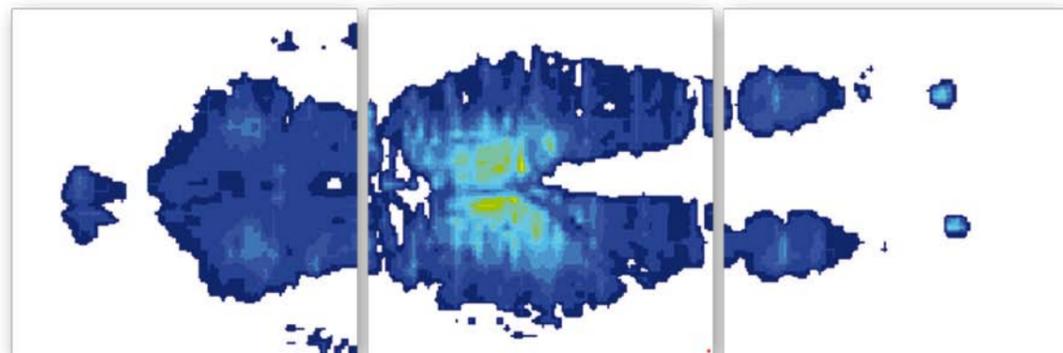
45° Head of bed elevation

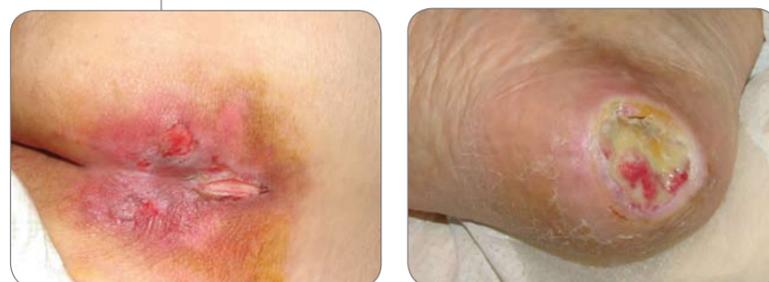
➤ PRESSURE ULCERS: SACRUM & RIGHT HEEL 17TH DECEMBER 2007

- On clinical assessment, the patient had a Stage 2* pressure ulcer at the sacrum with partial loss of skin thickness: epidermis and derma. The lesions were superficial and consisted of abrasions with a shallow ulcerous lesion.
- The second pressure ulcer was a Stage 3* pressure ulcer on the right heel, with total loss of skin thickness and necrosis of the subcutaneous tissue. This was a deep lesion with a clear demarcation on the inside edge of the heel.

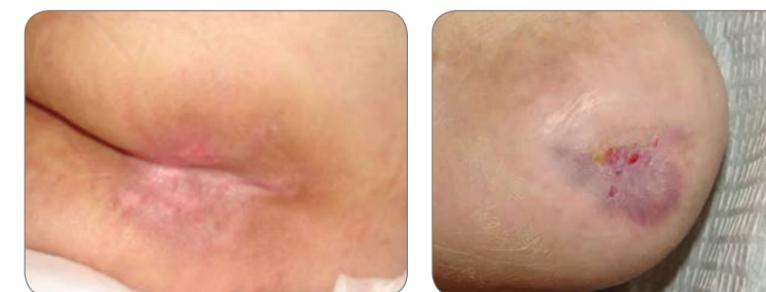
➤ PRESSURE ULCERS: SACRUM & RIGHT HEEL 8TH FEBRUARY 2008

- The sacrum healed completely in 8 weeks,
- The heel had almost completely healed by this time.

Results after 2 months' Hill-Rom P330 Wound Surface use
